**Flood Control Project Maintenance
Levee Inspections**

Maintenance Issue Types Only, Levee Inspection Report By Mile - Fall 2015

Reclamation District No. 2075 McMullin

Waterway	Bank	Unit Miles	Inspection Start/End	Inspector
Unit No. 01 San Joaquin River	Right	7.45	09/29/2015 09/29/2015	Herman Phillips

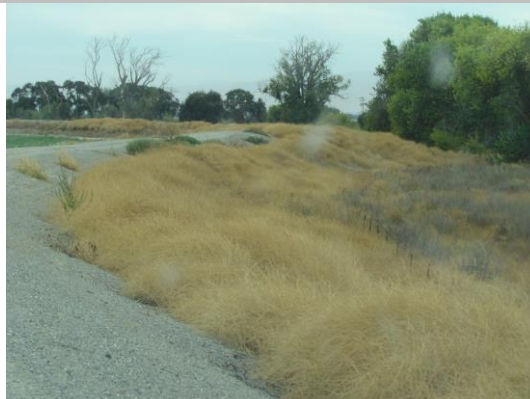
Photo 1 of 1 : FA_2015_RD2075_315_8_20151001_00009.jpg

LM Start	0.09	Rating **	U	Issue No.	8
LM End	0.14	Issue Type +	Ma	Location *	WS
Category	Earthen Levee			GPS Latitude/Longitude	
				Start	End
Item	Vegetation			37.748575 °	37.747847 °
				-121.289728 °	-121.289550 °
DWR ID	DWR_RD2075_01_f _ 2015_8				
Action/Comments					
Control annual grass and weeds on the levee slopes and easements. Inspector Comments: Remove the sprayed weeds from the waterside slope.

Waterside levee slope looking downstream slope covered with tumbleweeds.

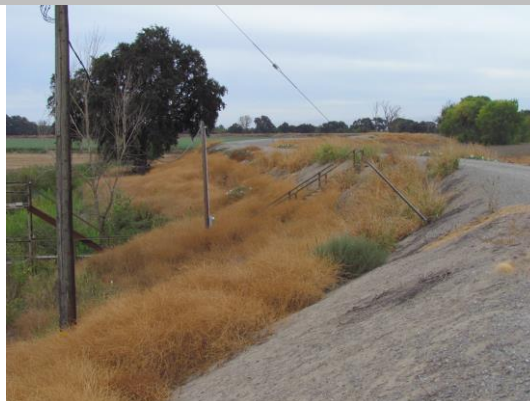
Photo 1 of 1 : FA_2015_RD2075_315_7_20151001_00010.jpg

LM Start	0.09	Rating **	U	Issue No.	7
LM End	0.47	Issue Type +	Ma	Location *	LS
Category	Earthen Levee			GPS Latitude/Longitude	
				Start	End
Item	Vegetation			37.748575 °	37.743222 °
				-121.289728 °	-121.289183 °
DWR ID	DWR_RD2075_01_f _ 2015_7				
Action/Comments					
Control annual grass and weeds on the levee slopes and easements. Inspector Comments: Remove the sprayed weeds from the levee section.

Looking downstream from landside levee slope, weeds were sprayed not dragged off slope.

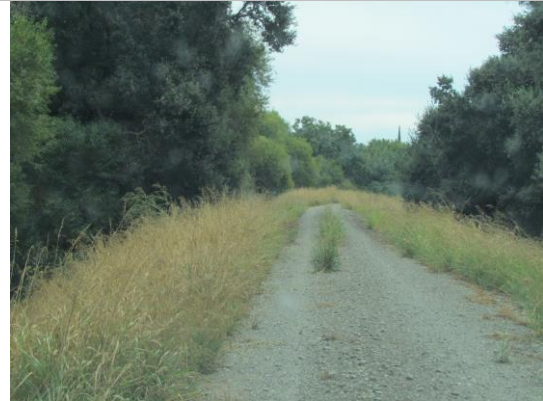
Photo 1 of 1 : FA_2015_RD2075_315_15_20151001_00011.jpg

LM Start	1.14	Rating **	U	Issue No.	15
LM End	1.36	Issue Type +	Ma	Location *	LS
Category	Earthen Levee			GPS Latitude/Longitude	
				Start	End
Item	Vegetation			37.737962 °	37.735370 °
				-121.281678 °	-121.282915 °
DWR ID	DWR_RD2075_01_f_2015_15				
Action/Comments					
Control annual grass and weeds on the levee slopes and easements.

Looking downstream at the landside levee slope johnson grass is present from shoulder to toe, same for the waterside slope.

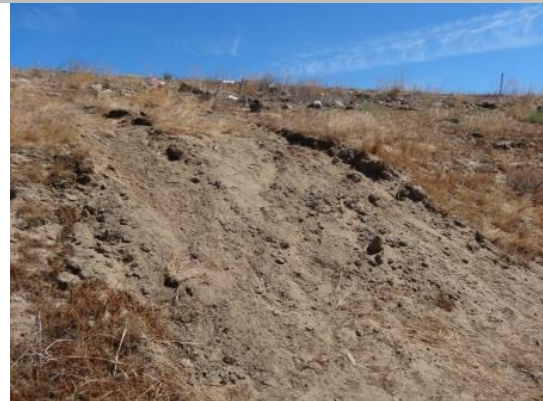
Photo 1 of 3 : SJR2015_RD2075U01RM64.34_13.jpg

LM Start	5.28	Rating **	M	Issue No.	1
LM End	5.29	Issue Type +	Ma	Location *	WS
Category	Supplemental			GPS Latitude/Longitude	
				Start	End
Item	DWR Erosion Survey			37.727933 °	37.727933 °
				-121.274491 °	-121.274491 °
DWR ID					
Action/Comments					
<p>Inspector Comments: 08/28/2015: No significant change observed. Loose material is visible at the upper levee slope. The loose soil may have been caused by runoff.</p> <p>08/18/2014: No significant change observed.</p> <p>09/10/2013: No significant change observed.</p> <p>09/13/2012: No significant change observed.</p> <p>08/18/2011: No significant change observed. Some new material added to the water side levee slope, but the added material is loose and seems not helping the levee protection.</p> <p>10/05/2010: No significant change observed. Levee slope has minimal vegetation and lacks rip rap protection. Sandy material found on the lower and middle slope is an undesirable material to have on a levee.</p> <p>08/05/2010: Recommended for annual assessment and monitoring during flood events, per CLRO.</p> <p>08/20/2009: No major change since last visit; site is located in an oxbow; slope surface consists of very sandy material; there is a tree on site leaning and with exposed tree roots; site is recommended as a local maintenance issue, per CLRO CES Evaluation 2008 Report; Eddy Cordoza from the district is aware of the site and is looking for recommendation; site is previously rated "U".</p> <p>08/17/2007: Site is close to an irrigation pump inlet. [2015 Site ID:RD2075U01RM64.34]</p>

Direct view of the levee slope. Note the loose soil possibly caused by runoff.

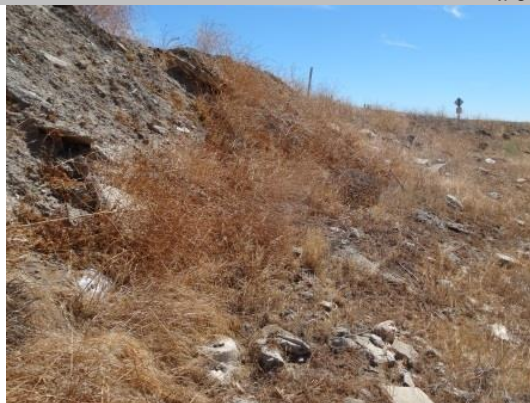
Photo 2 of 3 : SJR2015_RD2075U01RM64.34_15.jpg

Inspector Comments: 08/28/2015: No significant change observed. Loose material is visible at the upper levee slope. The loose soil may have been caused by runoff.
 08/18/2014: No significant change observed.
 09/10/2013: No significant change observed.
 09/13/2012: No significant change observed.
 08/18/2011: No significant change observed. Some new material added to the water side levee slope, but the added material is loose and seems not helping the levee protection.
 10/05/2010: No significant change observed. Levee slope has minimal vegetation and lacks rip rap protection. Sandy material found on the lower and middle slope is an undesirable material to have on a levee.
 08/05/2010: Recommended for annual assessment and monitoring during flood events, per CLRO.
 08/20/2009: No major change since last visit; site is located in an oxbow; slope surface consists of very sandy material; there is a tree on site leaning and with exposed tree roots; site is recommended as a local maintenance issue, per CLRO CES Evaluation 2008 Report; Eddy Cordoza from the district is aware of the site and is looking for recommendation; site is previously rated "U".

Looking downstream at the erosion site.
